TRUCK AIR PARTS®

SERVICE BULLETIN

EXAMINING COMPRESSOR FAILURES IN THE FIELD

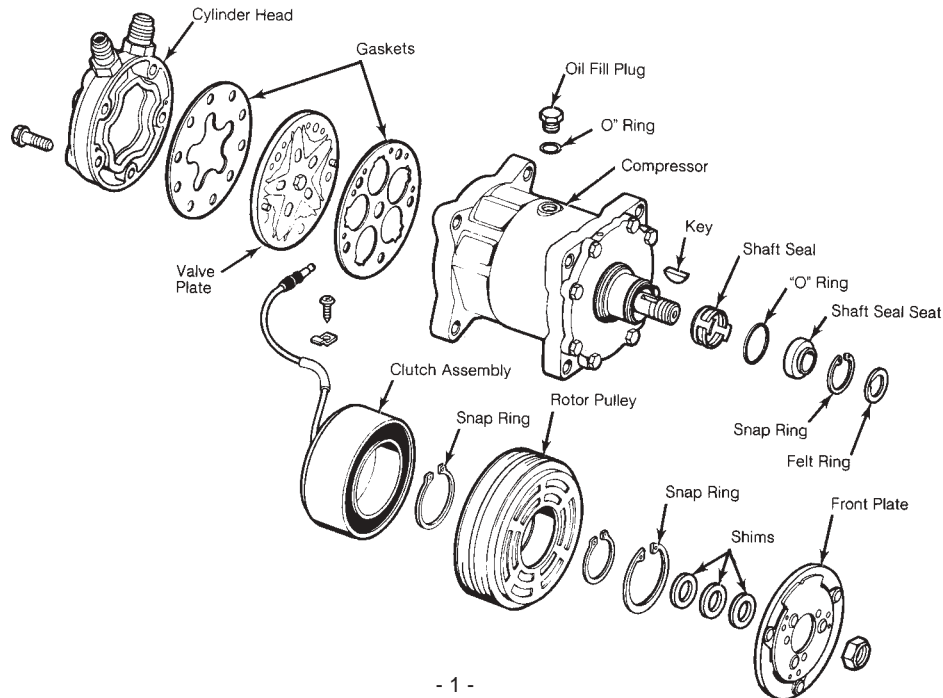
To assist you in analyzing compressor failures, a diagram of a typical compressor & clutch assembly is shown. This diagram should be used as a reference when attempting to determine the cause of failures in the various components of the compressor. The terminology used below will be referred to throughout this Service Bulletin.

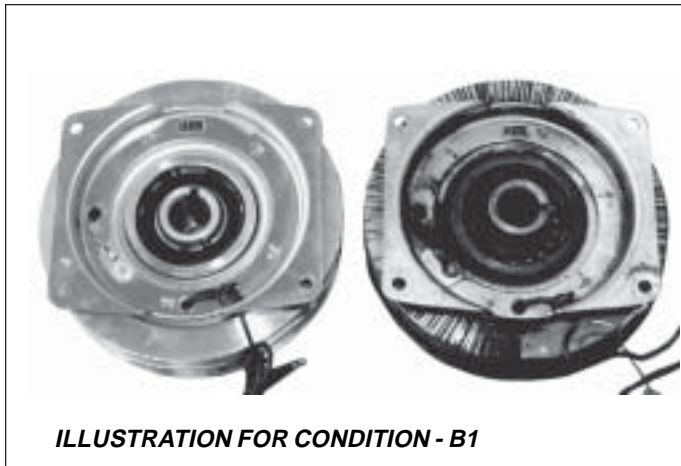
ILLUSTRATION FOR CONDITION - B1

B1. Burnt Clutch Hub, Pulley, and/or Coil

Inadequate voltage to the coil will result in overheating of the internal winding, and cause the clutch hub to slip against the face of the pulley. A compressor in the stages of failing due to slugging or loss of lubrication, or operating under a high pressure condition will also cause the clutch to slip. The slipping occurs continuously and in just a short time will subject both the clutch and coil to extreme temperatures up to 1,200 degrees F. This will quickly destroy the clutch and its internal components. Visual evidence of this type of failure can be found in the illustrations on page 2. This type of failure affects both the compressor and clutch and subsequently voids the warranty on the entire assembly.

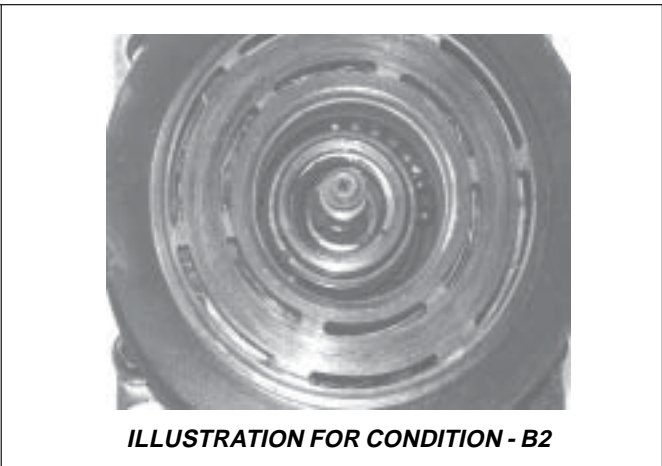
ILLUSTRATION FOR CONDITION - B2

B2. Clutch Bearing Failure

Bearing failures are usually caused by system related problems. Very seldom is a bearing itself the culprit of a failed or locked up compressor. For example, if the clutch slips severely due to a high pressure or low voltage condition, or due to compressor slugging, the excessive heat generated by the slipping will quickly melt and destroy the bearing seal. The bearing then loses its grease and locks up or falls apart, usually destroying the clutch in the process. This type of bearing failure is not covered under warranty, since the bearing was not the root cause of the problem. Manufacturing defects in clutch bearings are rare, and warranty allowances are usually associated with excessive noise symptoms only (see following condition).

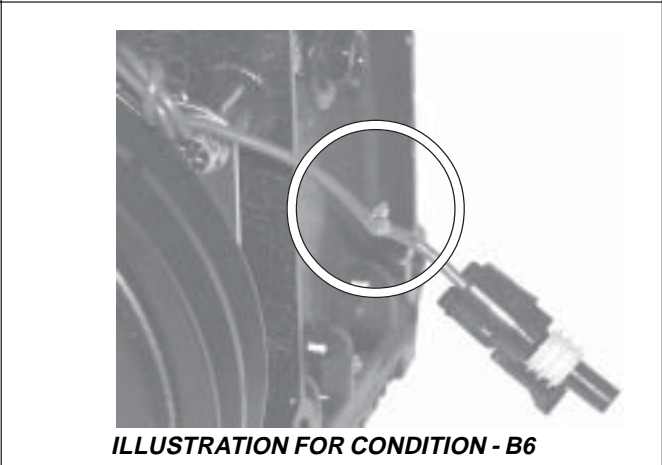
ILLUSTRATION FOR CONDITION - B6

B6. Faulty Coil Lead Wire or Inadequate Voltage to Coil

If the lead wire connected to the field coil is faulty, the clutch becomes inoperative. This will be evident at the time of installation, and seldom occurs afterwards. However, evidence of obviously damaged or cut lead wires is not a cause for warranty consideration. There must be adequate voltage to the coil in order for the clutch to function properly. A compressor clutch that fails to engage can usually be traced to an open or faulty circuit. Since many compressor clutches are now equipped with a separate wiring harness to ground the clutch, insufficient grounding of the circuit may be the problem. Compressors returned for warranty which check out to function properly but have evidence of being mounted and cannot be resold as new, will be denied.

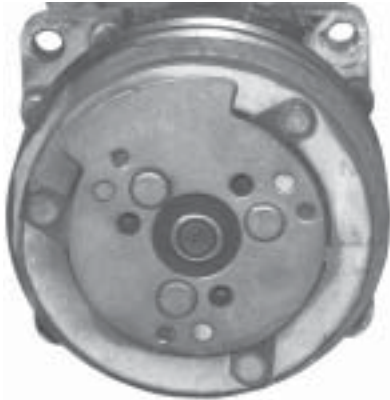
ILLUSTRATION FOR CONDITION - C1

C1. Seized (Locked Up) Compressor due to Loss of Lack of Lubrication

Compressor lock-ups also involve the clutch. The clutch's function is to engage and disengage the compressor from the vehicle's accessory drive system. If there is a system problem that prevents proper rotation of the compressor input shaft while the clutch is energized, the clutch will slip. A slipping clutch can generate tremendous heat, up to 1,200 degrees F. In a matter of minutes, components can start to fail. There is a progression of effects generated from slipping, all leading to overall clutch and/or compressor failure.

1.) *Discoloration of Pulley and/or Armature Disc*

The extreme heat generated from slipping will quickly cause the component(s) to take on a discolored appearance. They will appear “frosted”, or “blued”, or even charred.

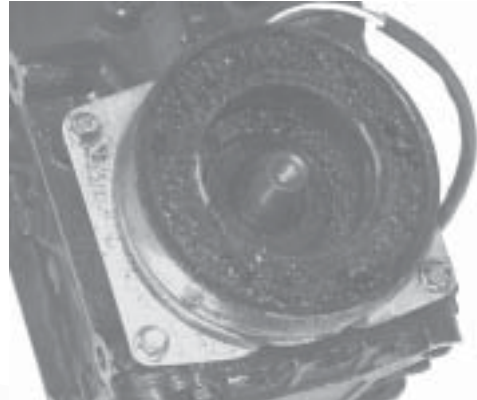
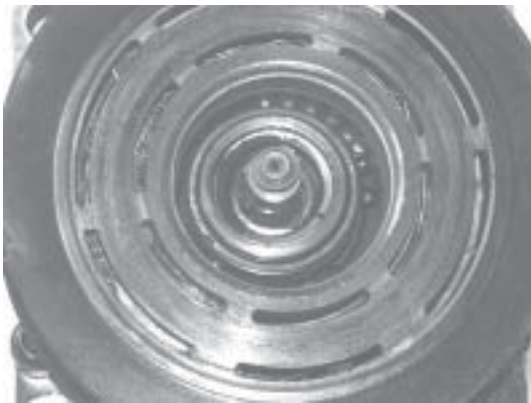
ILLUSTRATION FOR CONDITIONS - C1, C2

C2. Seized (Locked Up) Compressors due to Excessive A/C System Pressure

Every one of the following conditions will increase system pressure. Just as too high blood pressure causes the heart to overwork, and prematurely fail, excessive A/C system pressure can cause the compressor to overwork and begin to seize. This in turn increases the torque requirements of the clutch. The clutch then begins to slip, producing tremendous heat build-up. The clutch bearing fails, and the clutch seizes. As the compressor attempts to continue operating under this overwhelming condition, failure is eminent.

2.) *Melting of Rubber Spacers in Armature*

If the slipping continues, the temperature can reach a point where the rubber spacers between the armature plate and disc begin to melt. Not all clutches utilize rubber spacers.

3.) *Melting of Epoxy in Field Coil*

The extreme heat can also affect the field coil, causing the epoxy to show visual signs of melting or “charring”. Under extreme situations, the coil winding will become exposed and/or unseated.

4.) *Melting of Bearing Seal*

The heat will eventually cause the bearing seal to melt, allowing the grease to escape. Without grease to lubricate the bearing, it is quickly destroyed.

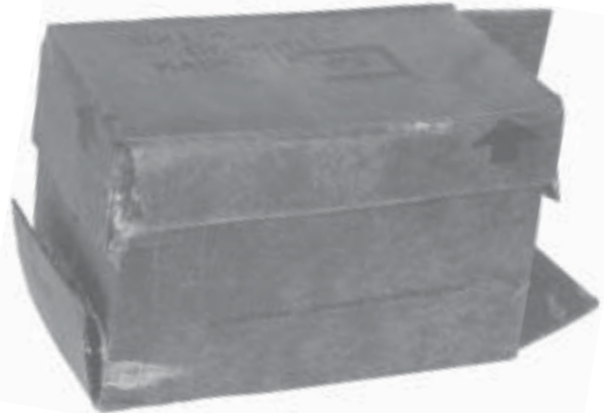
ILLUSTRATION FOR CONDITION - C6

C6. CCI/York Compressors with Oil Leaks

Sometimes a warranty is claimed if a compressor is found to be soaked with oil before ever being sold or installed onto a system. This is usually the case when someone notices the compressor's box to be discolored, oil stained, and possibly sitting in a pool of oil, while still on the shelf. Sometimes the oil has even penetrated adjoining compressor boxes alongside. What to do? The compressor(s) are not defective. In nearly every case we have found the following to apply. The compressor's shipping caps, which are plastic, unknowingly become cracked or loosened during shipment. The compressors are then stocked on the shelf in a horizontal position, which allows gravity to take effect and leak oil onto the compressor body and box. Should you find this to happen, do not call for RGA's to return them. The problem is limited to CCI/York style compressors and we can supply replacement boxes for any you might have. Stocking these compressors in the upright position they are intended to be stored will help prevent this from happening. Again, this is not a warranty situation.

- J. **This is not a warranty related problem.** The shipping caps are either cracked or loose. The box is being stored in a horizontal position, rather than upright as it should. The compressor is still good and usable. Do not return! **Read Section C6.**

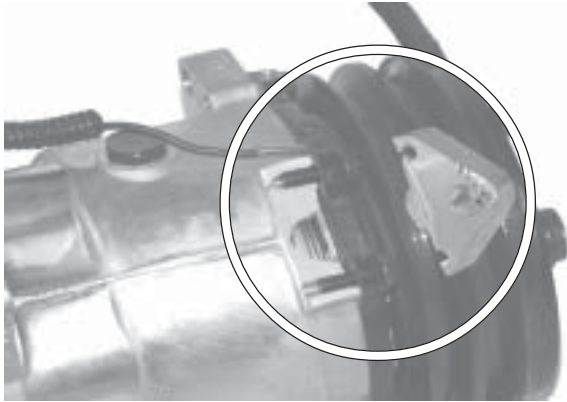
ILLUSTRATION FOR CONDITION - D1

D1. Broken Mounting Ear(s) on Compressor

If the compressor is mounted improperly, or in any way as would subject it to cross-torque on its mounting ears, one or more of the ears will likely crack or break. This may lead to additional damage of the compressor itself. The same problem can occur if the compressor's engine mounting brackets are cracked, warped, or broken. A vehicle with loose or broken motor mounts can also subject the compressor to additional strain and crack or break off its ears. Excessive noise during compressor operation may be evident during these types of situations. Simply replacing the compressor will not fix the problem. Unless the cause of the problem is found and fixed, the likelihood of another broken compressor is high. Many times ears are broken or cracked simply as a result of excessive torque applied during installation of the mounting hardware, such as from use of an impact wrench.

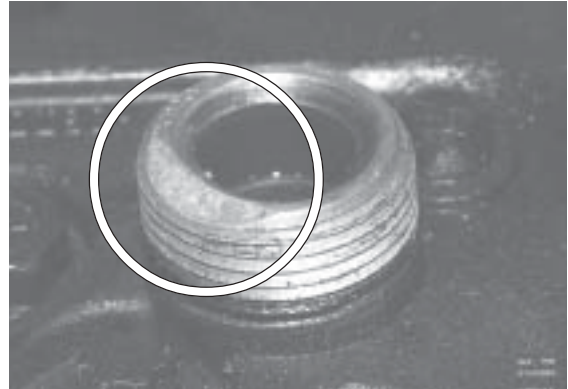
ILLUSTRATION FOR CONDITION - D2

D2. Broken (or Stripped) Fittings on Compressor

Broken fittings can usually be traced to either excessive torque applied during installation of the service valves or hose fittings, such as from use of an impact or oversize wrench, or cross-torque being applied to the fittings. The most common cause stems from one of the hose assemblies (suction or discharge) being replaced with one shorter in length than the original OE hose. As the driver increases engine RPM, torque is applied to the hose. Because of the decreased distance in hose length between the two fitting attachments, the law of least resistance takes effect and the aluminum compressor head fitting snaps off. This may lead to additional damage of the rest of the compressor. Stripped fittings on the other hand, are always due to incorrect fastening techniques on the part of the installer. In some cases a replacement compressor head is available to salvage the loss.

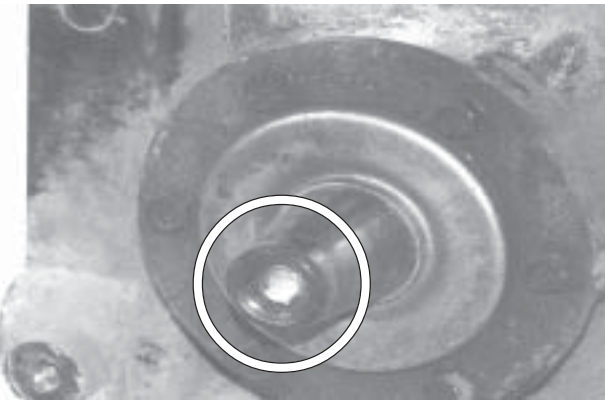
ILLUSTRATION FOR CONDITION - D3

D3. Use of Excessive Torque on Compressor Shaft Mounting Bolt

Broken or twisted clutch shaft bolts are the result of excessive torque applied during installation, such as from use of an impact wrench. Check manufacturer's torque specifications when installing clutch hardware.

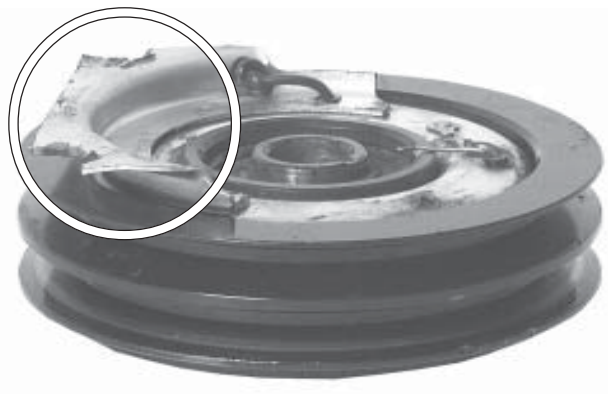
ILLUSTRATION FOR CONDITION - D4

D4. Loose Field Coil Mounting Bolts

If the bolts used to mount the field coil are not tightened adequately, vibration from the vehicle will loosen the bolts and cause the coil to become loose. Eventually the field coil will begin to contact the rotor assembly, as evidenced by rubbing on the field core outer diameter. This rubbing can generate heat that melts the field coil epoxy, leading to an open circuit and inoperative clutch. This condition is specific to CCI/York/Tecumseh style compressors. The replacement clutches for these compressors are now normally supplied with special thread-lock treated fasteners. New CCI Compressor & Clutch assemblies are already equipped with them. Use of the fasteners normally solve this kind of problem, unless a severe vibration problem exists.

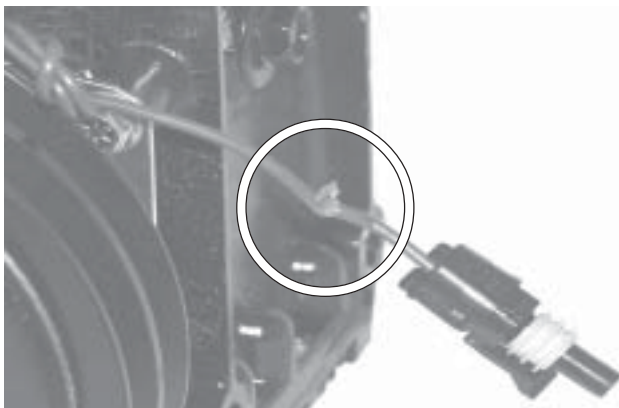
ILLUSTRATION FOR CONDITION - D5

D5. Short or Open Circuit in Field Coil Wire

If the clutch lead wire is routed in such a way as to subject it to possible rubbing or cutting by another object, the wire's insulation can be rubbed through and the bare wire exposed. A short circuit or open circuit will likely develop, causing the clutch to become inoperative. This type of failure is evidenced by a lead wire worn down to bare metal in one or more locations along its length, or a lead wire that gets cut in half.

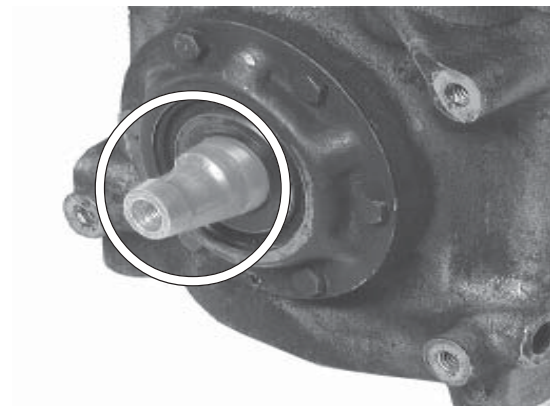
ILLUSTRATION FOR CONDITION - D7

D7. Shaft Key not Seated Properly in Armature Hub

If the key is not properly inserted into the keyway on the compressor input shaft during a clutch installation, a severe misalignment of the pulley relative to the shaft will occur. This misalignment will create interference between the rotor and field coil assemblies. Evidence of severe rubbing of the pulley on the field coil will be present.

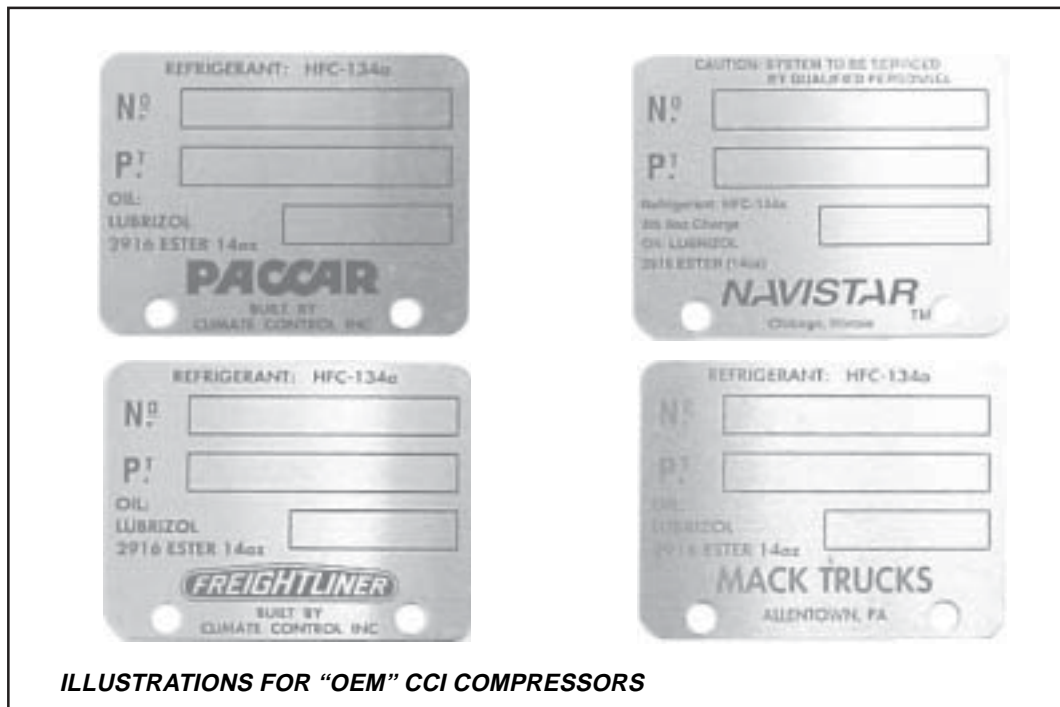
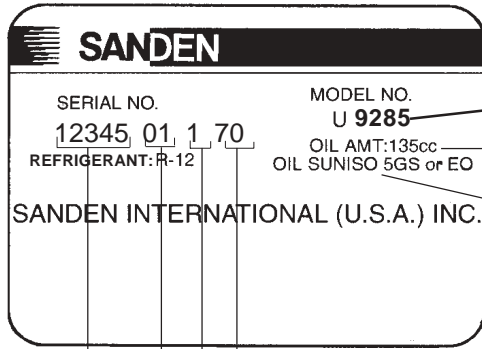
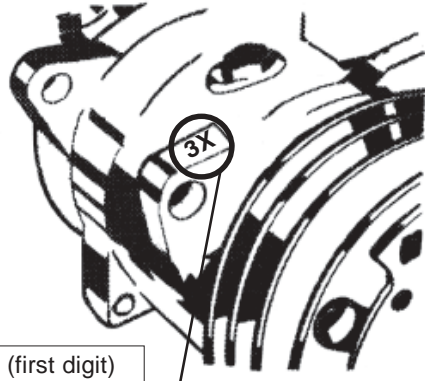
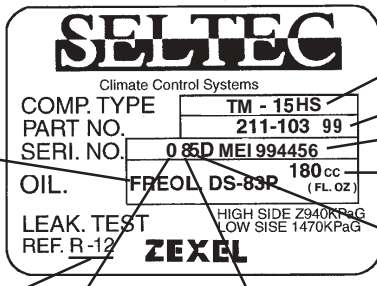
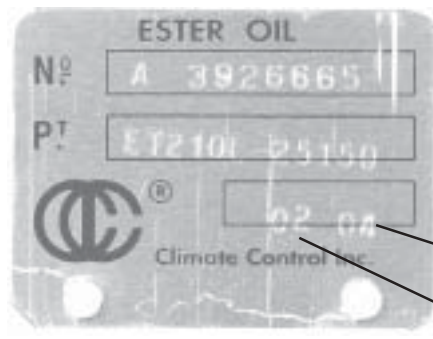
ILLUSTRATIONS FOR COMPRESSOR DATE CODES

Serial Number _____
 Month of Manufacture _____
 Year of Manufacture _____
 Country Code _____

00-06	Japan
70-79	USA
80-89	Singapore

Year of Manufacture (first digit)
 Month of manufacture (last digit)
 Jan-Sept.: 1-9
 Oct.: X
 Nov.: Y
 Dec.: Z

Designates Year of Manufacture:
 0 Represents 2000

Month Produced:
 1-6 January thru June
 7-12 July thru December

Decade Code:
 4 Represents first half of 1980's
 5 Represents second half of 1980's
 6 Represents first half of 1990's
 7 Represents second half of 1990's
 8 Represents first half of 2000's
